## SOUTH NEW RIVER CANAL

## PHYSICAL DESCRIPTION

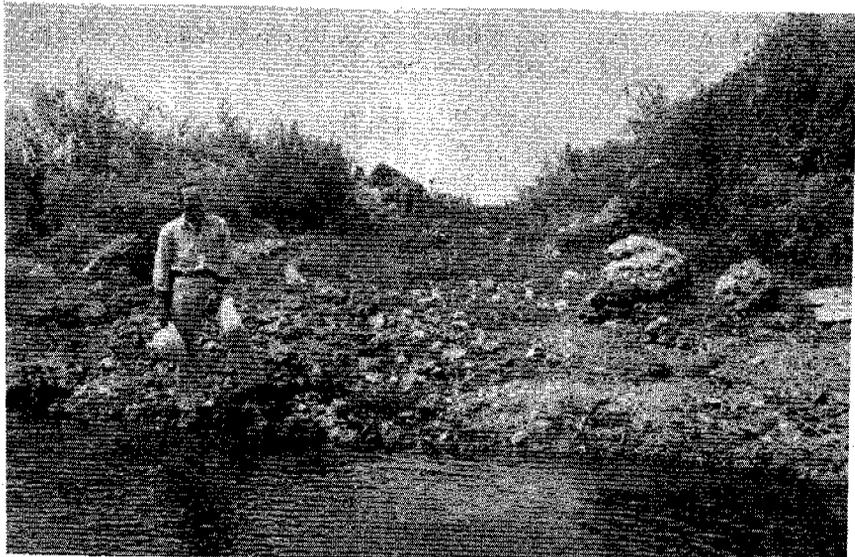
Figure 113. —View upstream in bed of Miami Canal; shallow excavation above head of deep channel. Photograph taken April 13, 1943, in dry period.
